INDOOR AIR QUALITY ASSESSMENT

**Ralph B. O'Maley Middle School
32 Cherry Street
Gloucester, Massachusetts**

Prepared by:
Massachusetts Department of Public Health
Center for Environmental Health
Emergency Response/Indoor Air Quality Program
March 2006

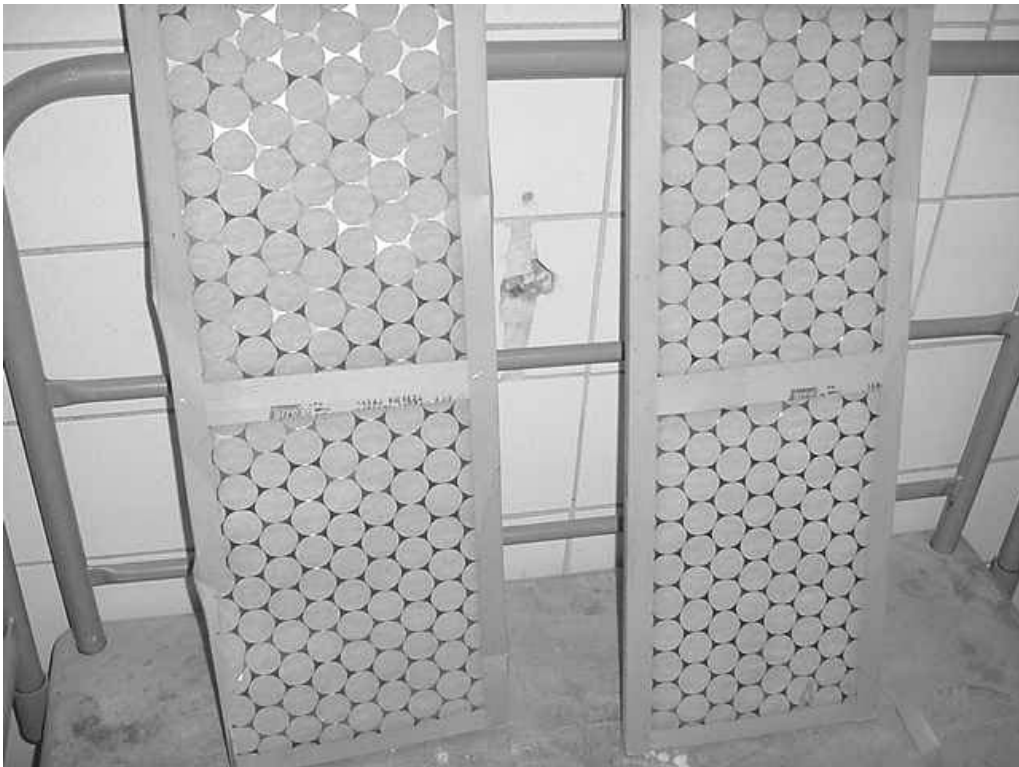
Picture 1

equipment is difficult to maintain due to decreased operating efficiency and the difficulty of obtaining compatible replacement parts. Univents are equipped with non-pleated filters of a low to medium efficiency (Picture 1). However, it is important to note that increased filtration (e.g., upgrading to higher efficiency filters) can reduce airflow produced by increased resistance, a condition known as pressure drop. Prior to any increase of filtration, univents should be evaluated by a ventilation engineer to ascertain whether they can maintain function with filters that are more efficient.

Medium Efficiency Univalent Filters

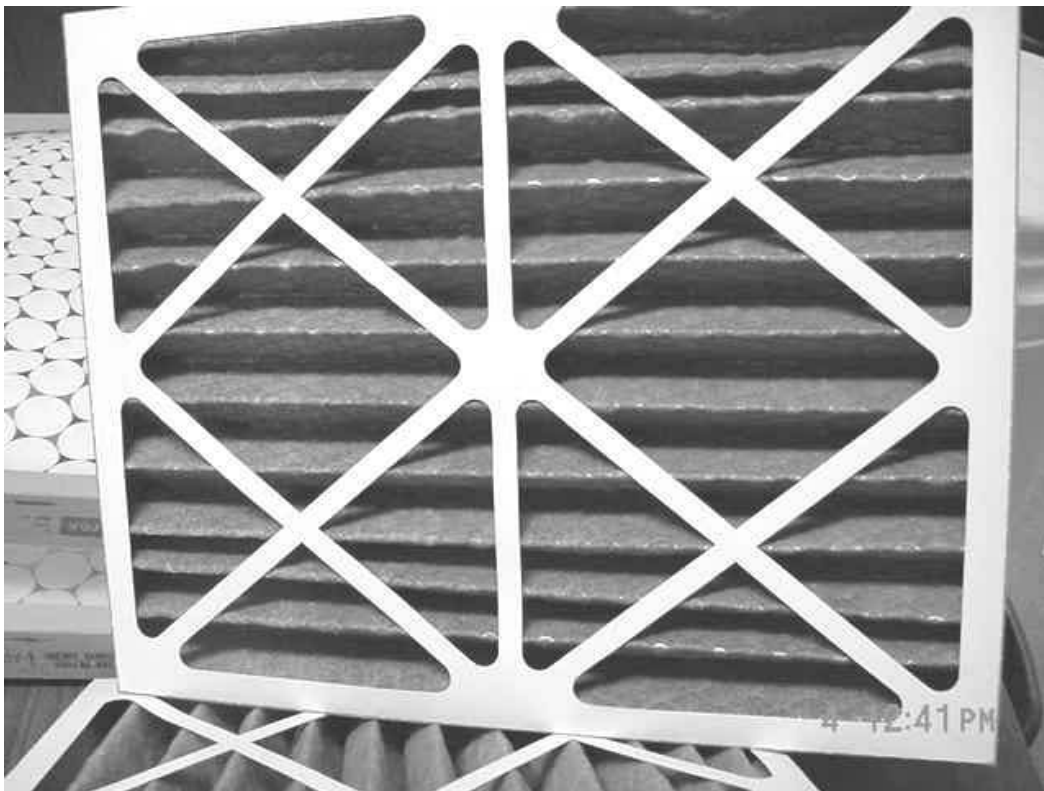
Picture 2

High Efficiency Pleated Air Filters

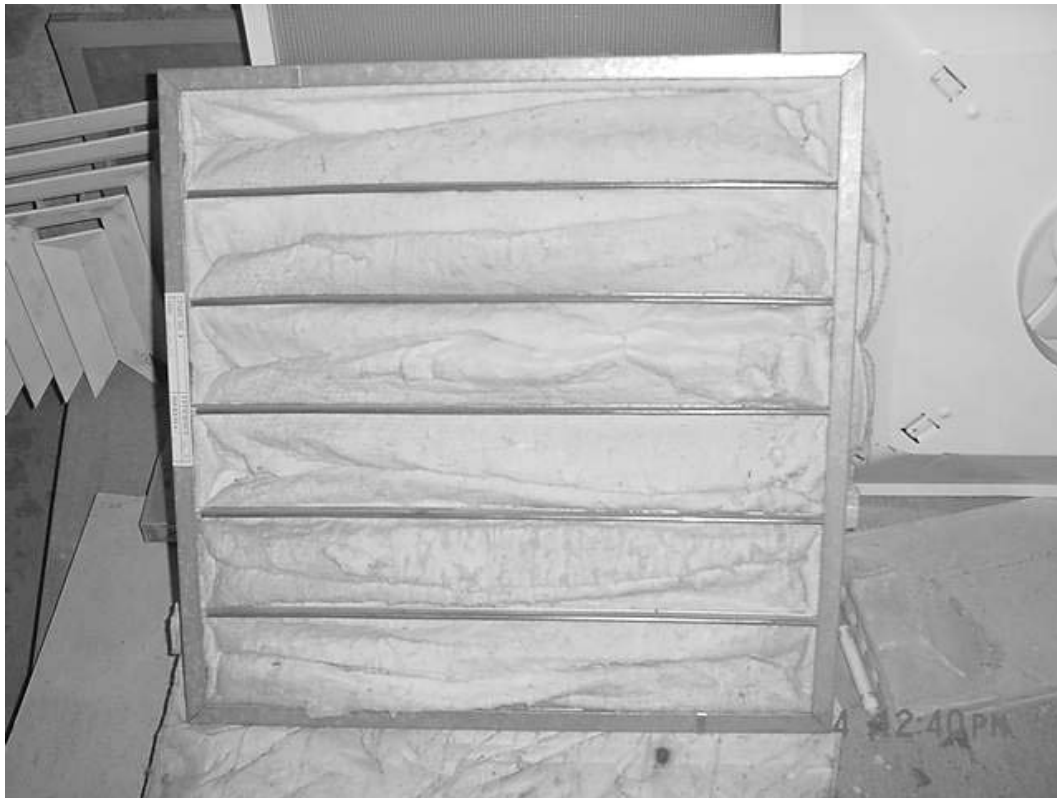
Picture 3

Secondary “Bag” Filtration System

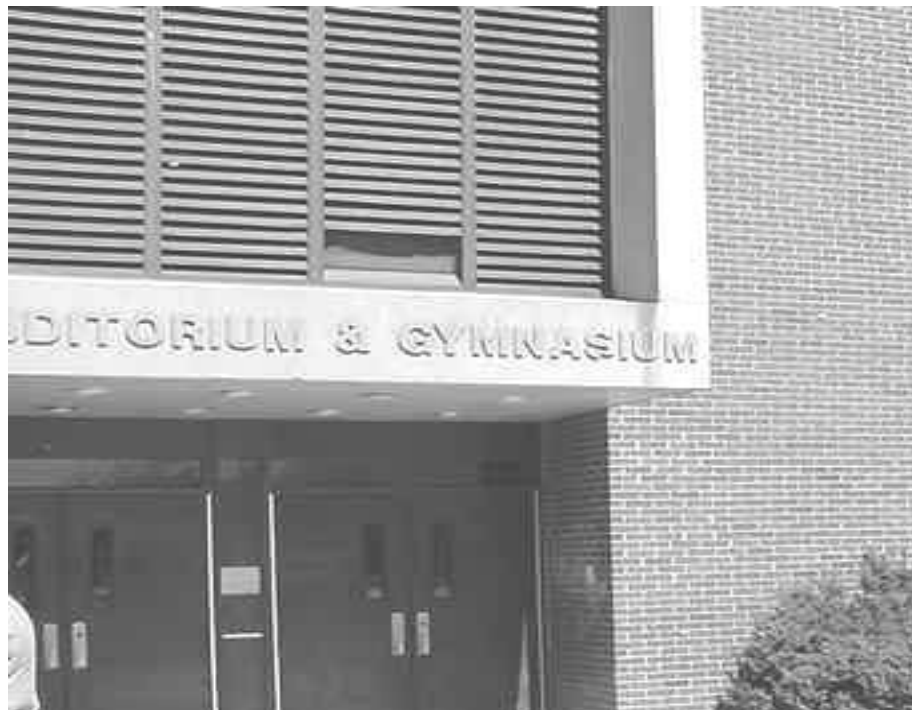
Picture 4

The role of the pumping station is to transfer waste from the North Gloucester/Wheelers Point area downhill to the gravity drainage system, which may then flow to the waste water treatment plant on Essex Ave. Ms. Christy Millhouse, Wastewater Treatment Plant Coordinator, Gloucester Department of Public Works (GDPW), reported that the pumping station has a large holding tank, which collects the raw sewage until it reaches a certain volume that triggers the pump to activate. Although a rare occurrence, under certain wind and weather conditions, odors generated at the pumping station may drift toward the school and be drawn into the mechanical ventilation system via outside air intakes (Picture 4).

Exterior of Gymnasium Fresh Air Intake, Note Air Intake Faces South in the General Direction of the Pumping Station (Approximately 0.3 Miles to the South/Southwest) see Figure 1

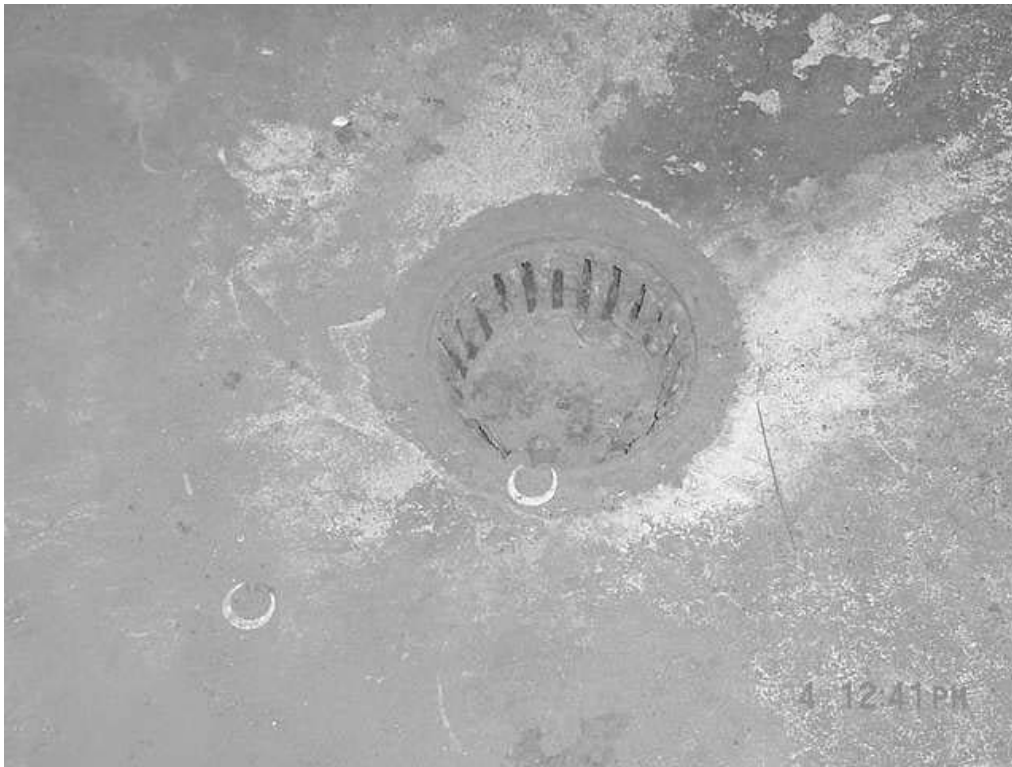
Picture 5

The second odor source is through the dry traps of floor drains in the boiler room, air handling unit rooms, restrooms and locker rooms beneath the gym (Picture 5). Drains are usually designed with traps in order to prevent the back up of sewer odors/gases from penetrating into occupied spaces. When water enters a drain, the trap fills and forms a watertight seal.

Typical Floor Drain (one of 55)

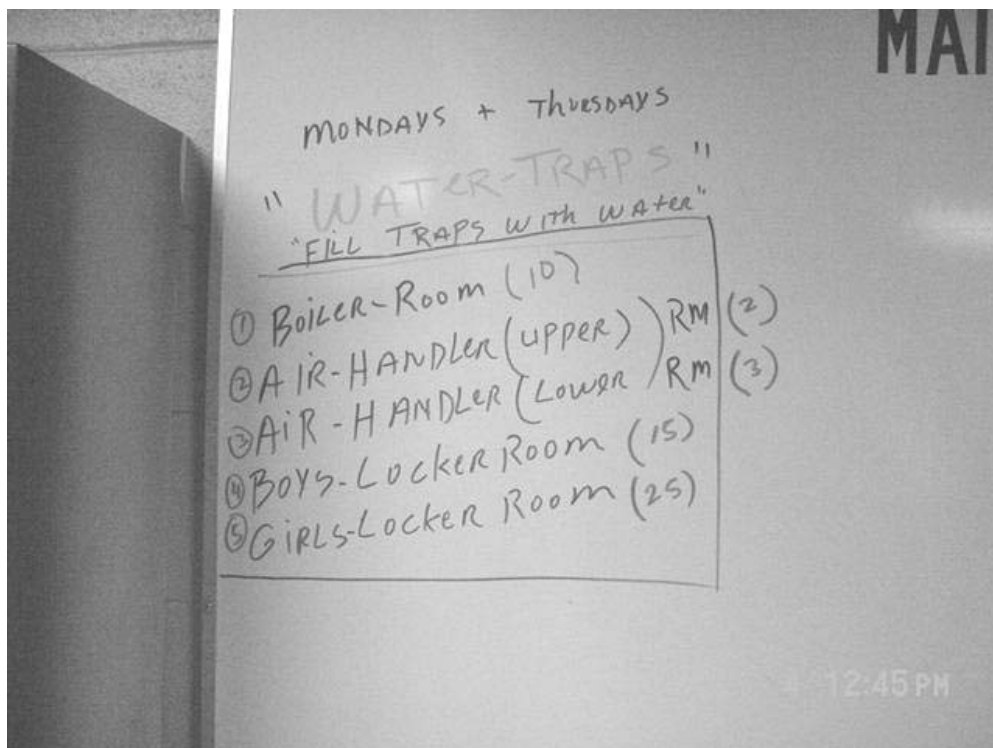
Picture 6

Without a watertight seal, odors or other material can travel up the drain and enter the occupied space. The maintenance of drain traps at the OMS requires vigilance due to the large number of traps located on floors throughout the building. There are 55 such traps in the building, which include 25 drains in the girl's locker room, 15 in the boy's locker room, 10 in the boiler room, 3 in the lower AHU room and 2 in the upper AHU room (Picture 6). As a result of on-going issues with odors associated with dry drain traps, GSD officials have instituted a program assigning a specific individual to fill all traps with water twice a week (Picture 6). The program reportedly commenced on December 1, 2005. As of February 24, 2006, MDPH staff confirmed with Dr. Michael Tracy, Principal, OMS that no odors had been reported since the trap filling program was instituted.

List of Location and Number of "Water-Traps" (i.e., Floor Drains) on Wall of Maintenance Office and Schedule on top Indicating to Fill Traps Twice a Week

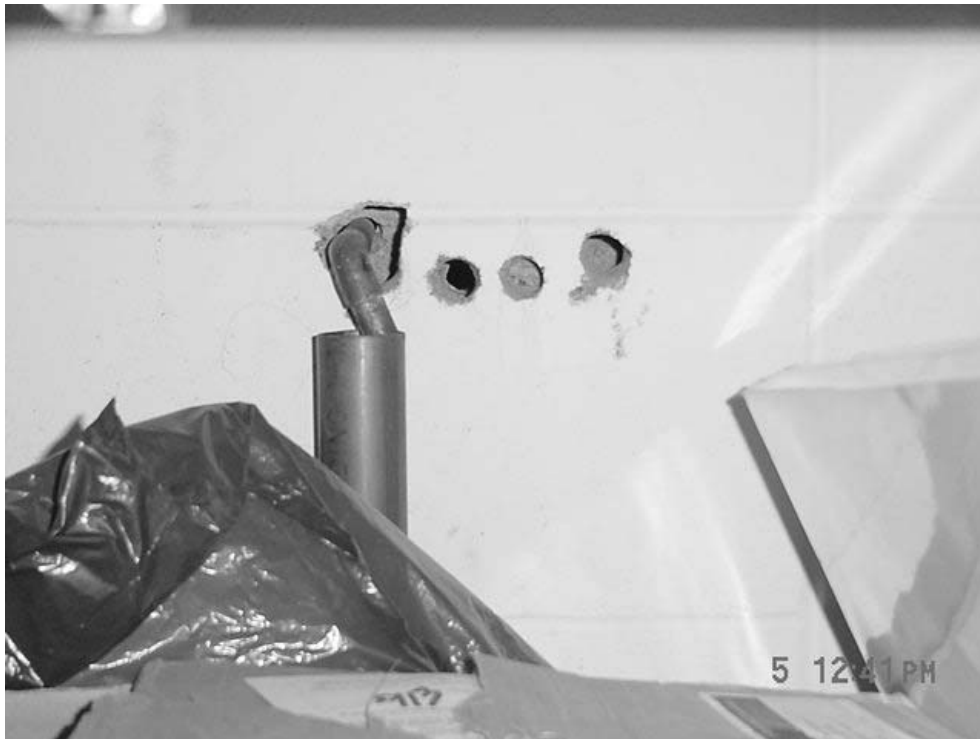
Picture 7

During the course of the current MDPH assessment, an undocumented drain was discovered in classroom 223 (Picture 7). This drain was installed to drain condensation from a portable air-conditioning unit located in the computer network room (Picture 8). At the close of the January 5, 2006 visit MDPH staff recommended to GSD officials that the drain in room 223 be added to the list located in the maintenance office (Picture 6). In addition, MDPH staff recommended that the spigot emptying into the drain be extended (e.g., rubber tubing), *into* the drain, to ensure proper drainage.

Drain from AC Unit in Network Room Protruding From Wall Emptying into Drain Pipe, Note Shortness of AC Spigot, Which Barely Extends into Drain Pipe

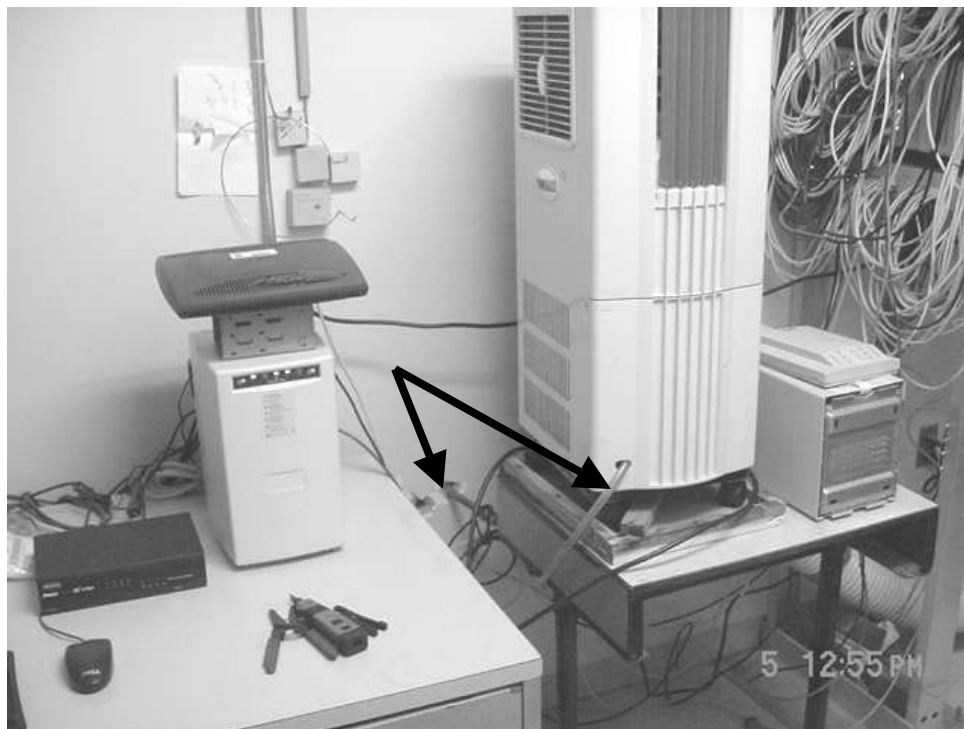
Picture 8

Portable AC Unit on Table in Network Room Adjacent to Classroom 223, Note Clear Tube Connected to Drain Pipe Protruding Through Wall

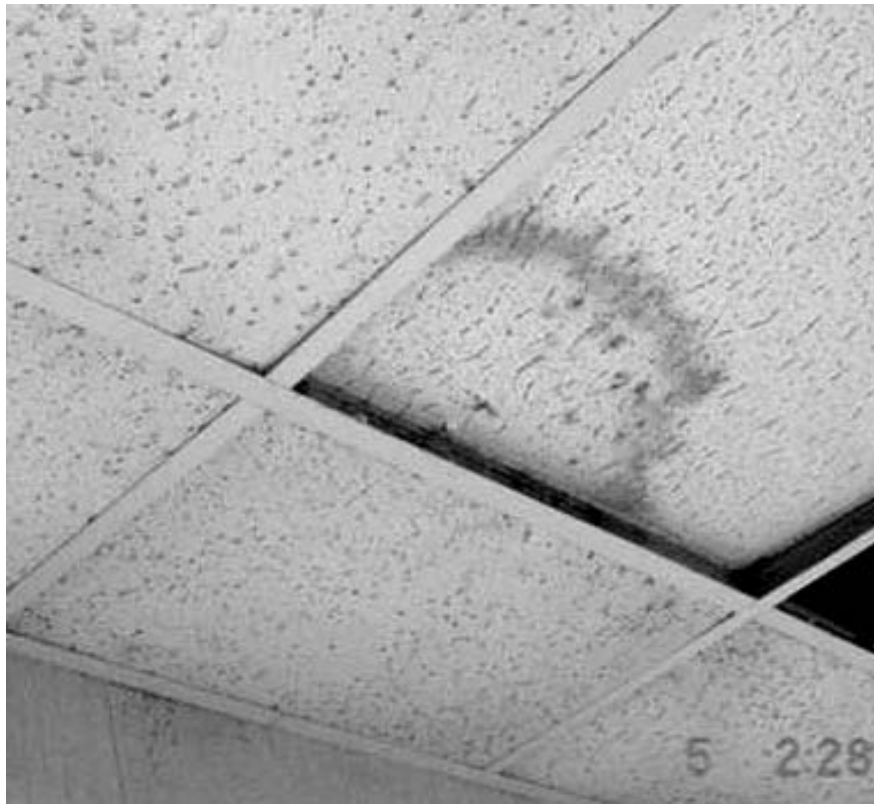
Picture 9

observed in the skate storage room (Picture 9). Active roof leaks were observed in the gymnasium near the locker room stairwell and in the hallway that connects the school to the ice rink. Water damaged ceiling plaster was also seen in the gymnasium (Picture 10); it was not possible to discern if the damage was current or evidence of an historic leak.

Water Damaged/Mold Colonized Tiles in Skate Storage Room

8. Identify and repair roof leaks in gymnasium, room 223 and the hallway to the skating rink.
9. Replace/repair any remaining water-stained ceiling tiles and building materials. Examine the area above and around these areas for mold growth. Disinfect areas of water leaks with an appropriate antimicrobial.

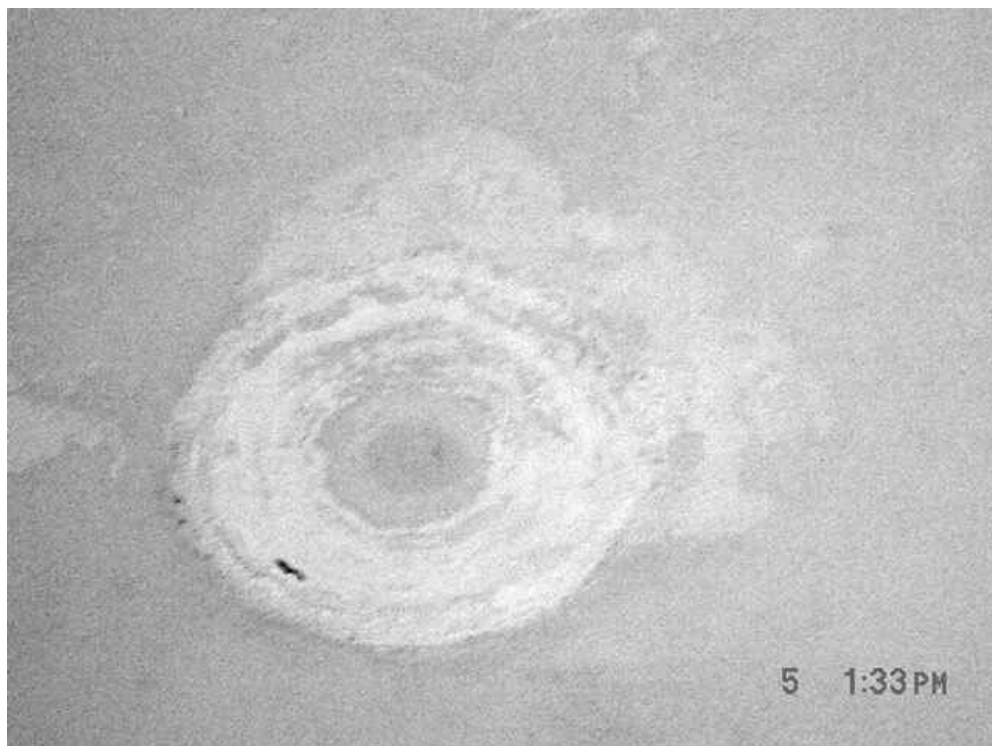
Picture 10

Water Damaged Ceiling Plaster in Gymnasium

11. Closely examine water damaged ceiling plaster in gymnasium (Picture 20), determine if area above the water damage is accessible (via catwalk, crawlspace, etc.) to determine if leak causing water damage has been eliminated.

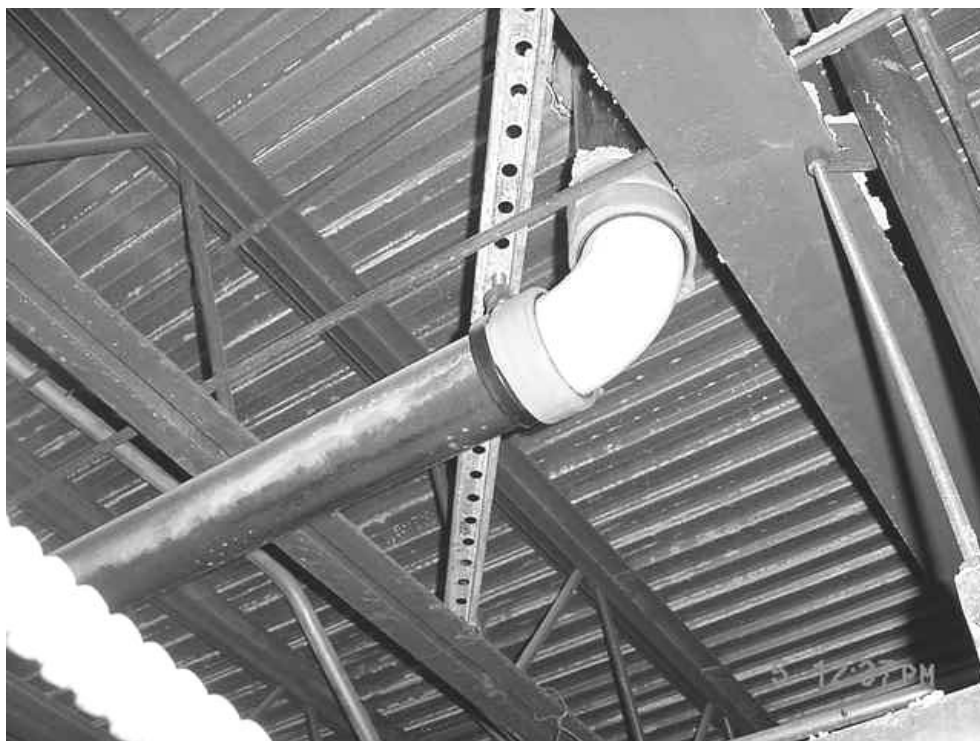
Picture 11

Periodic leaks were reported by one classroom occupant to occur in room 223 directly below an elbow joint for a drain (Picture 11). The drain itself did not appear to be the source of the leak but rather from a source above the roof deck. Water damaged ceiling tiles were also observed toward the rear of room 223. MDPH staff removed the tiles to examine conditions in the ceiling plenum, and found a section of uninsulated sheet-metal ductwork (Picture 12), which would suggest that condensation on the cool surface of the metal duct may be the moisture source damaging tiles. Occupants also expressed concern relative to whether old plumbing fixtures were sealed in room 223. MDPH staff examined decommissioned plumbing fixtures, which were found to be capped. However, water damaged porous materials were found behind cabinets in these areas, which most likely became wet from overflow during sealing of pipes (Picture 13).

Elbow Joint/Drain above Water Damaged Ceiling Tiles in Room 223

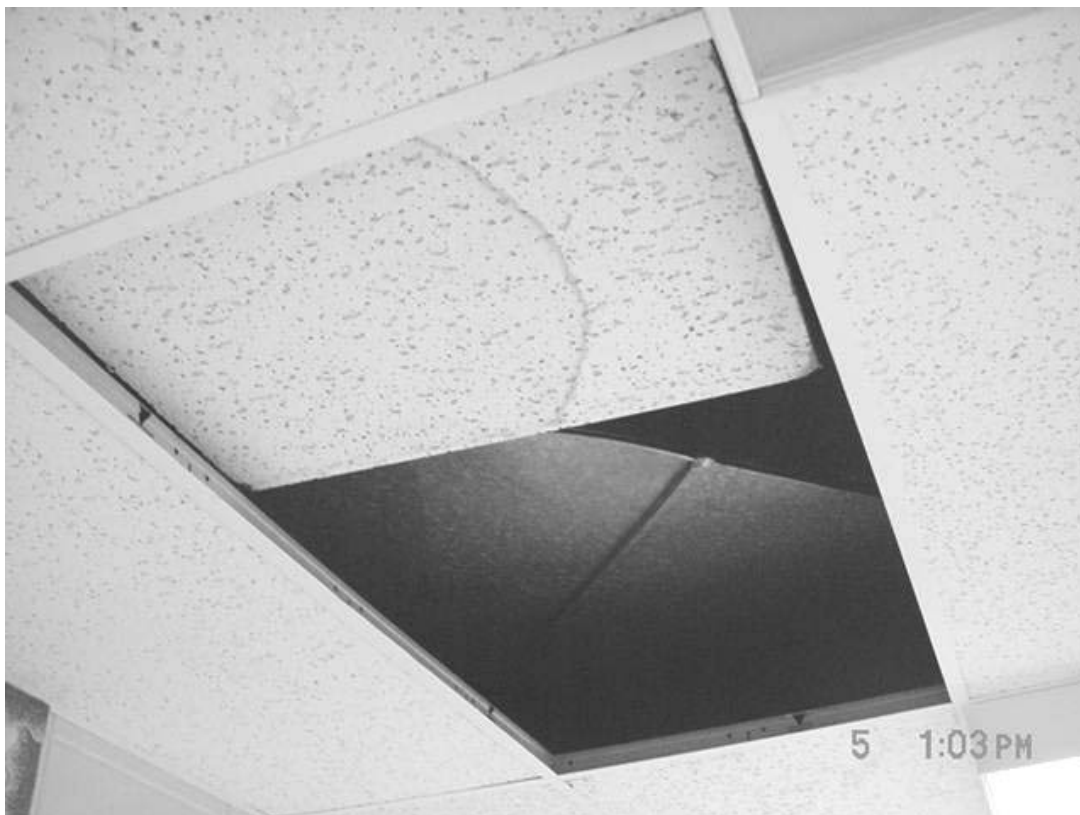
Picture 12

Sheet Metal Ductwork above Ceiling Tiles in Room 223

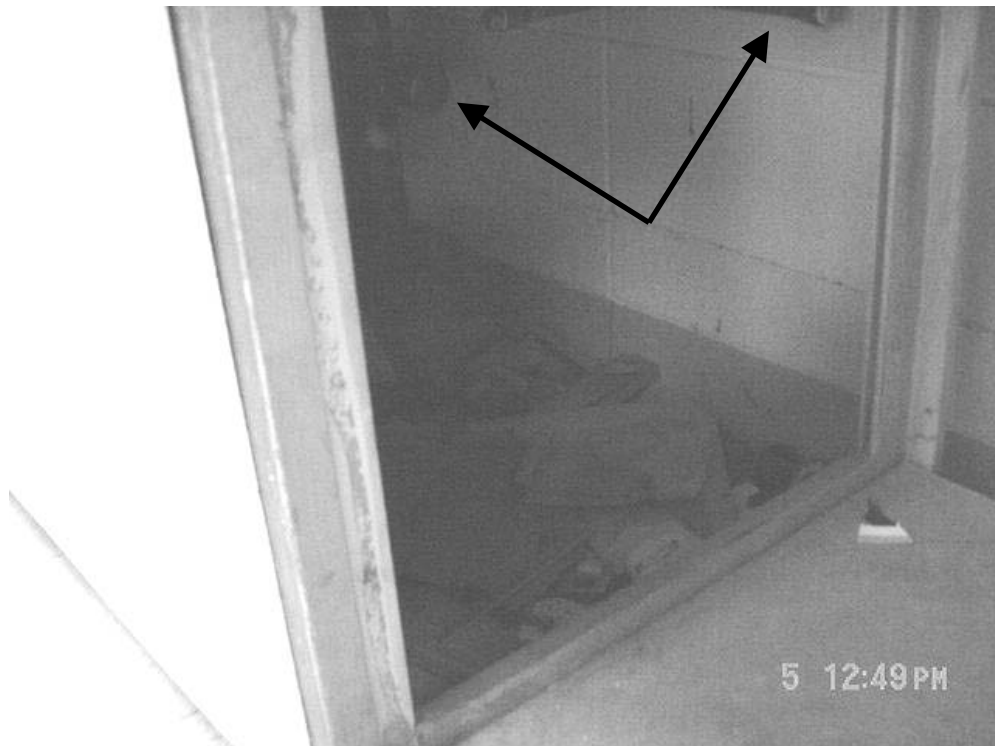
Picture 13

Capped Plumbing Fixtures and Water Damaged Porous Material, Trash and Debris behind Cabinet in Room 223

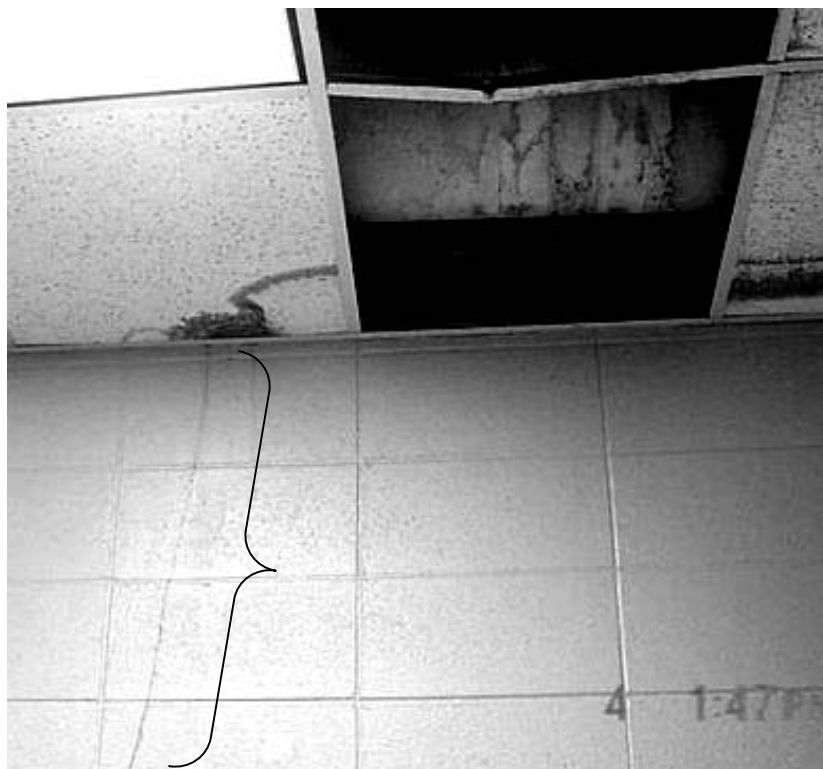
Picture 14

Missing/damaged tiles were observed in classroom 208 as a result of plumbing leaks that had reportedly been repaired just prior to the MDPH assessment. Concerns were also expressed by one occupant regarding staining of walls (Picture 14). MDPH staff recommended to the GSD and maintenance staff that the walls be cleaned and disinfected.

Water Damaged/Missing Ceiling Tiles in Room 208, Note Dark Streaks on Wall, Below Stained Tile

10. Clean and disinfect walls of room 208 (water streaks) beneath water damaged ceiling tiles.

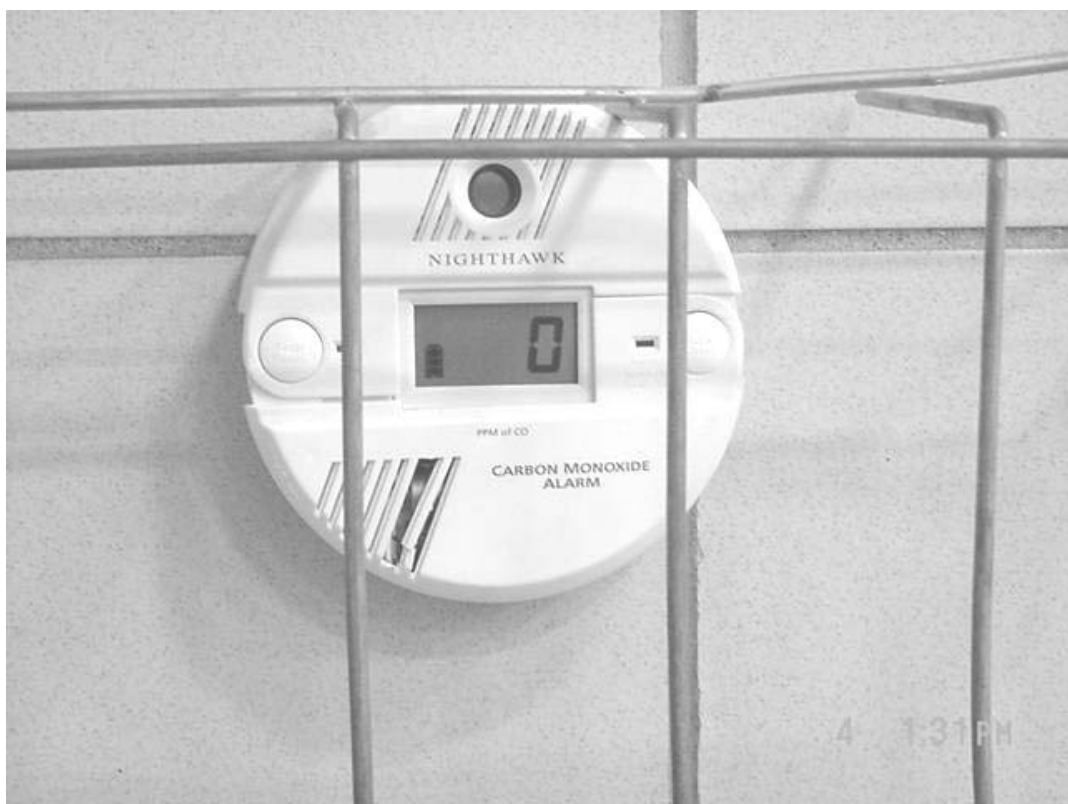
Picture 15

In response to previous concerns regarding carbon monoxide (CO) exposure, two wall-mounted, battery operated CO detectors were installed in the gymnasium (Picture 15). According to the manufacture's website, carbon monoxide alarms should be replaced every 5 years. In addition, alarms should be tested monthly to ensure proper working order and that batteries be replaced regularly to stay fresh (Kidde: <http://www.kiddeus.com/Replace+CO+Alarms.shtml>).

One of Two Carbon Monoxide Detectors in the Gymnasium

19. Replace carbon monoxide detectors every 5 years and test monthly to ensure proper working order as per the manufacture's recommendations.
20. Consider posting signs in the student drop off area instructing drivers to shut off engines after five minutes as required by Massachusetts General Laws 90:16A (MGL, 1986).

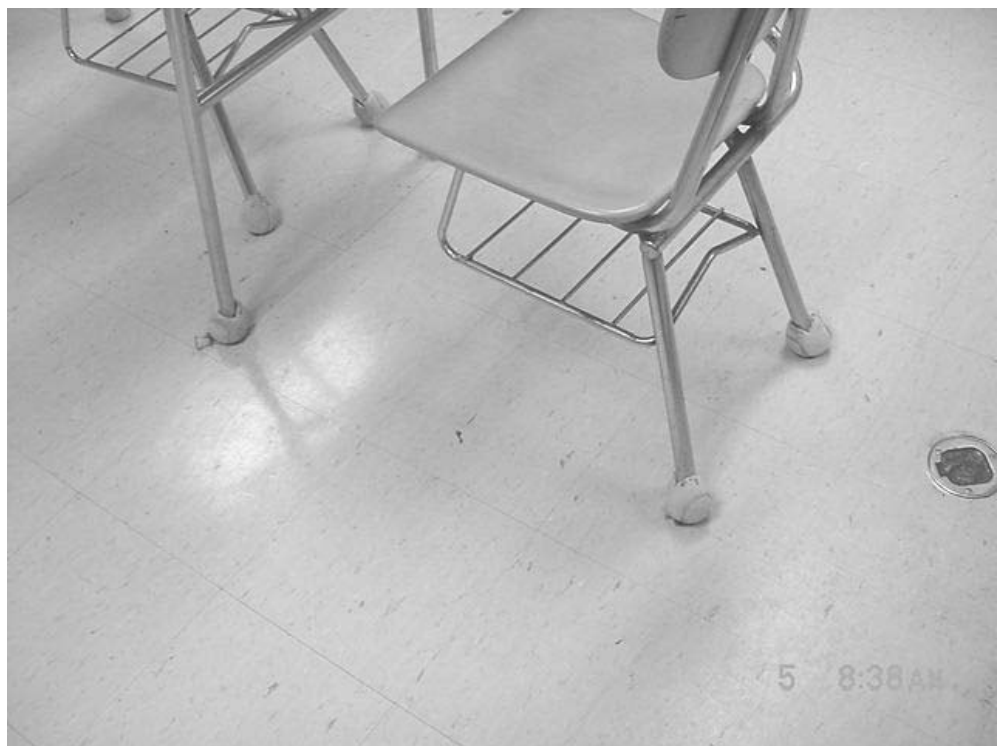
Picture 16

In an effort to reduce noise from sliding chairs, tennis balls had been sliced open and placed on chair legs (Picture 16). Tennis balls are made of a number of materials that are a source of respiratory irritants. Constant wearing of tennis balls can produce fibers and cause TVOCs to off-gas. Tennis balls are made with a natural rubber latex bladder, which becomes abraded when used as a chair leg pad. Use of tennis balls in this manner may introduce latex dust into the school environment. Some individuals are highly allergic to latex (e.g., spina bifida patients) (SBAA, 2001). It is recommended that the use of materials containing latex be limited in buildings to reduce the likelihood of symptoms in sensitive individuals (NIOSH, 1997). A question and answer sheet concerning latex allergy is attached as [Appendix B](#) (NIOSH, 1998).

Tennis Balls on Chair Legs in Classroom

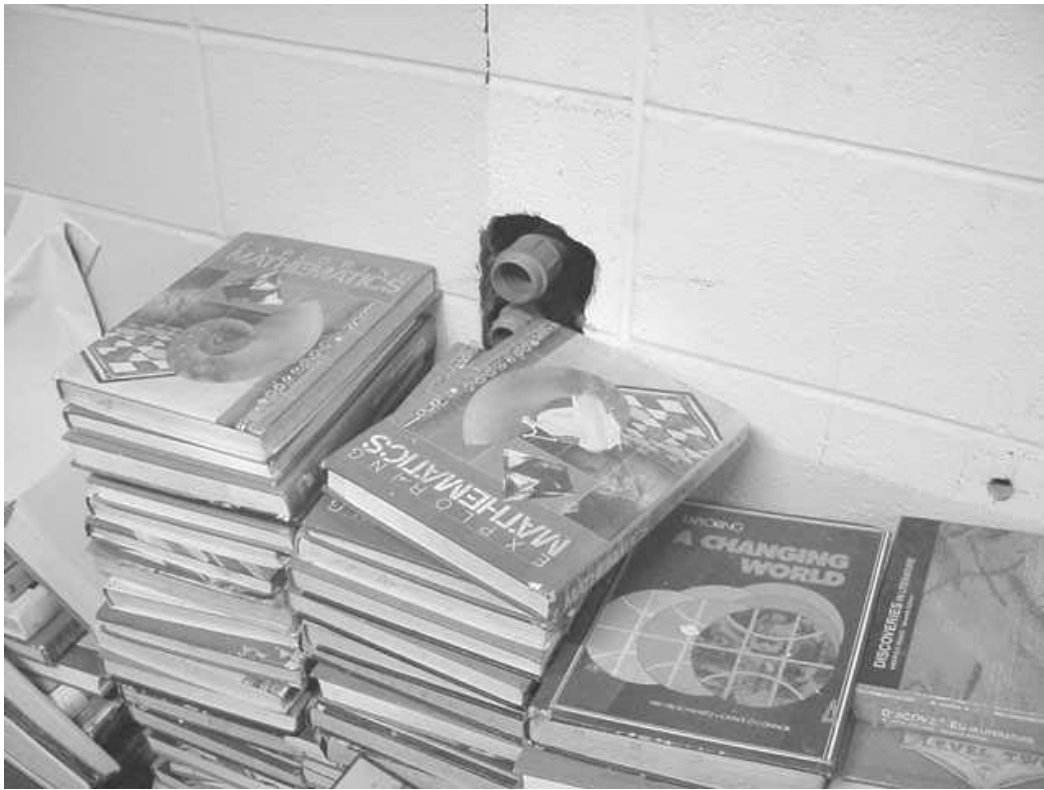
Picture 17

Open Utility Hole in Kiln Room Wall Separating the Kiln Room from the Boiler Room

12. Remove or reorganize stored materials to allow easy access to abandoned utilities in the kiln room.
13. Replace missing ceiling tiles and seal utility holes (e.g., art rooms, kiln room); to prevent the egress of drafts, odors and particulate matter into occupied areas.

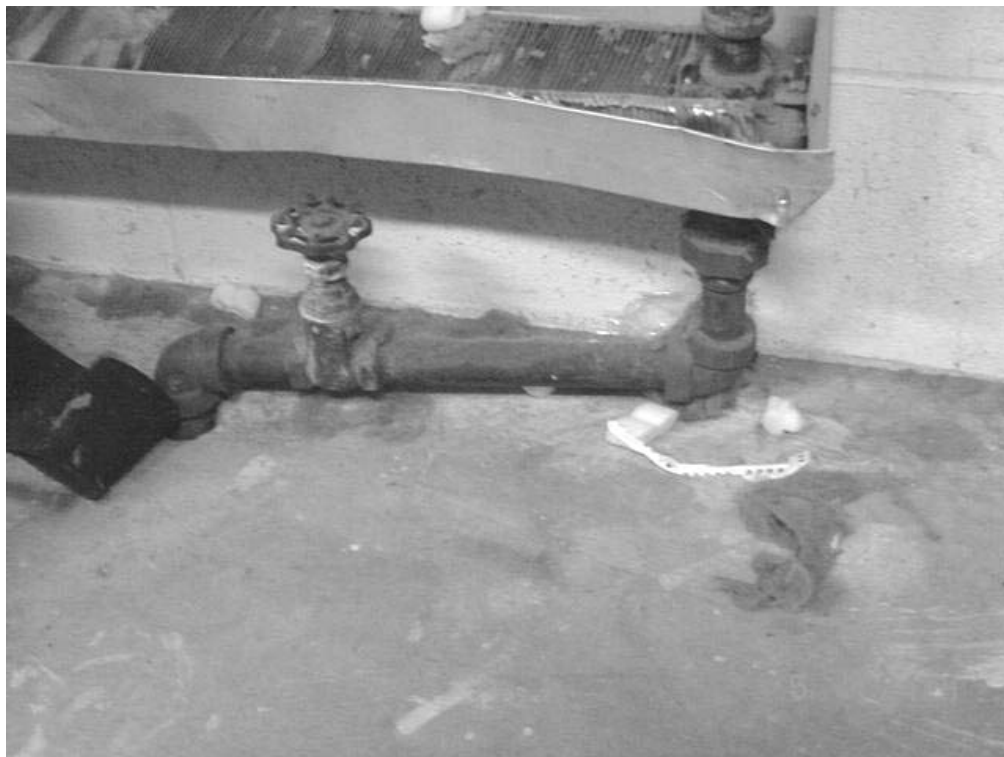
Picture 18

Dirt Dust and Debris on Floor of Gymnasium Storage Room

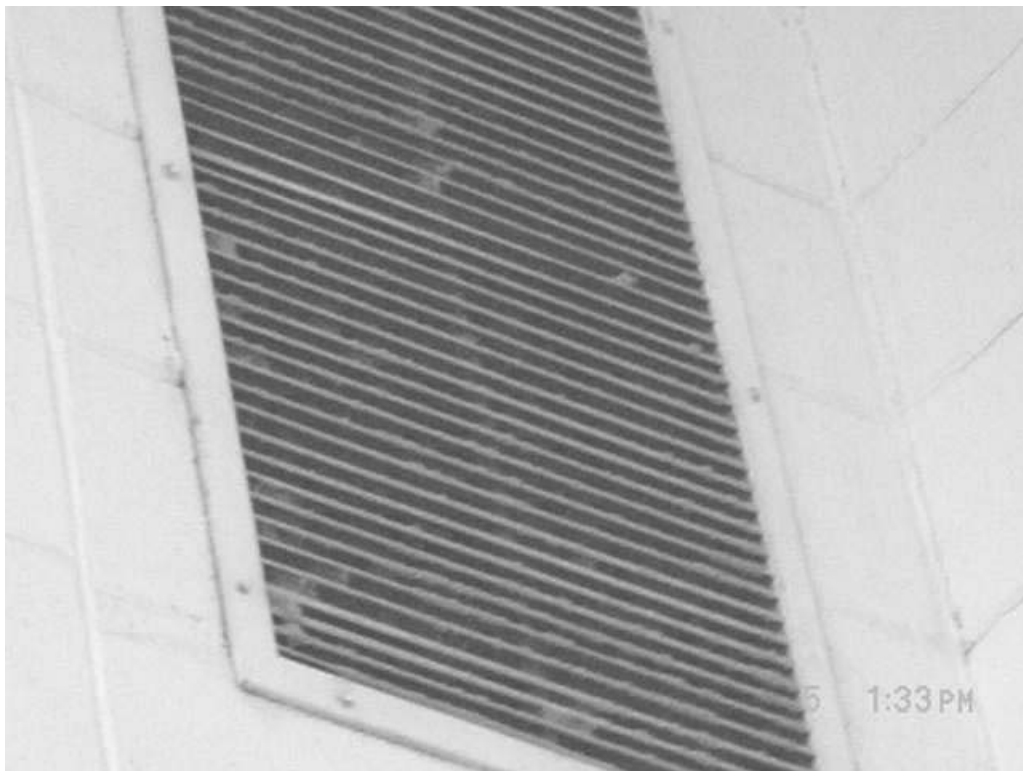
Picture 19

Dirt Dust and Debris between Louvers of Gymnasium Exhaust Vent

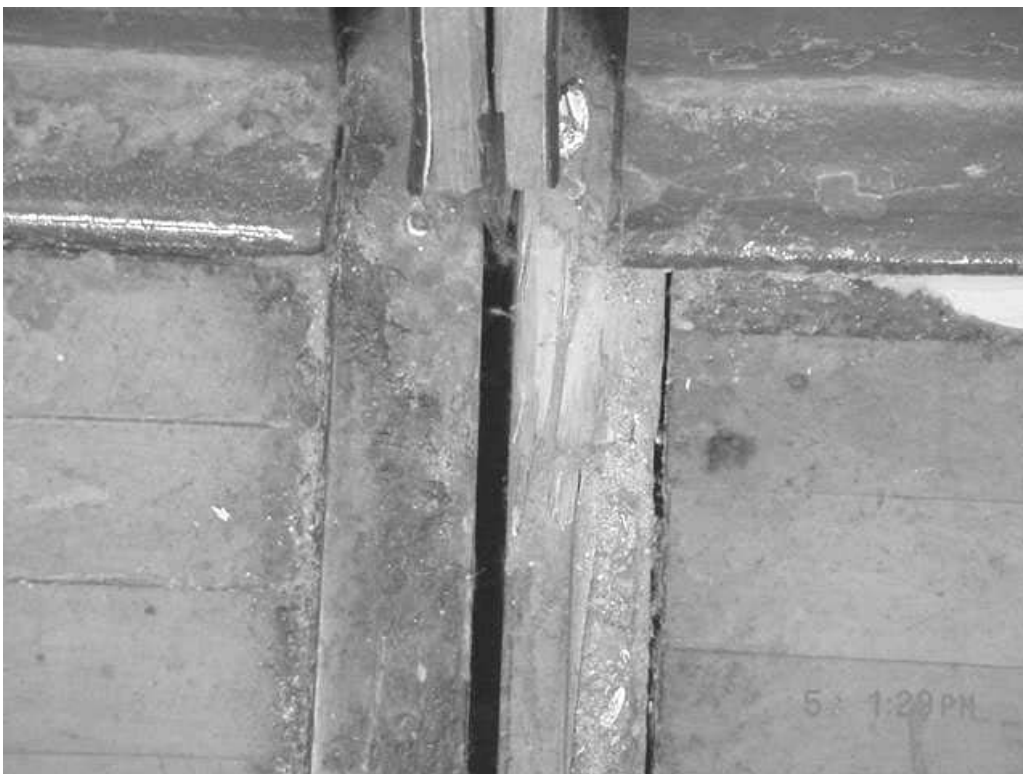
Picture 20

allowing dirt, dust and debris to collect in the track. Activity in the gym, coupled with low relative humidity during the heating season can create conditions to reaerosolization these materials, which can serve as eye or respiratory irritants. A number of exhaust and supply vents in classrooms also had accumulated dust (Picture 21). If exhaust vents are not functioning, backdrafting can occur, which can re-aerosolize dust particles. Dust particles can also be aerosolized when the supply system is activated.

Dirt Dust and Debris in Track Separating the Gymnasium

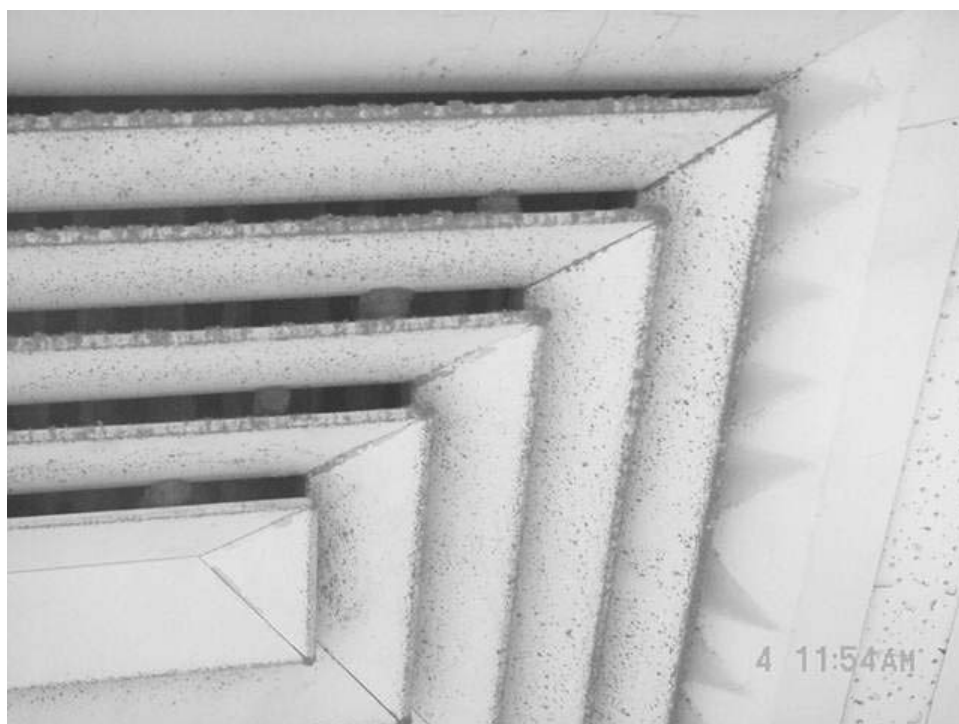
Picture 21

Accumulated Dust on Supply Air Diffuser Room 223

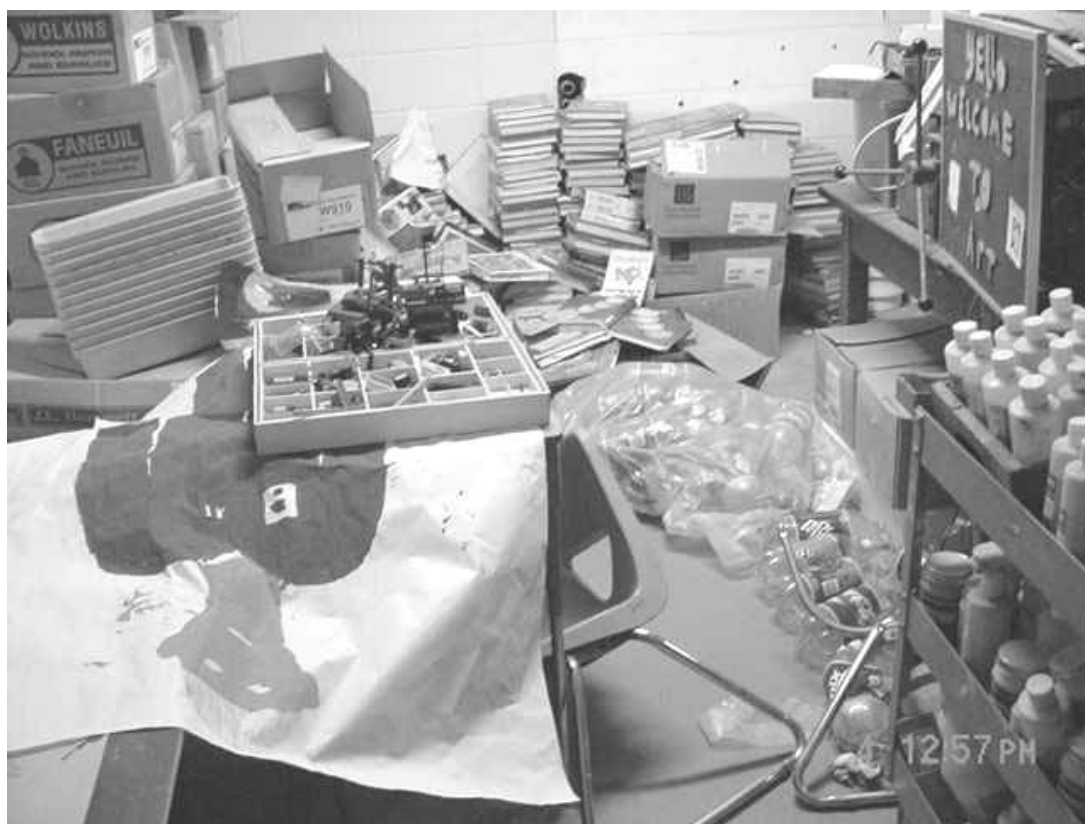
Picture 22

In several areas, items were observed on windowsills, tabletops, counters, bookcases and desks (Pictures 22 and 23). The large number of items stored provides a source for dusts to accumulate. These items (e.g., papers, folders, boxes) make it difficult for custodial staff to clean. Items should be relocated and/or be cleaned periodically to avoid excessive dust build up.

Accumulated Materials in Kiln Room

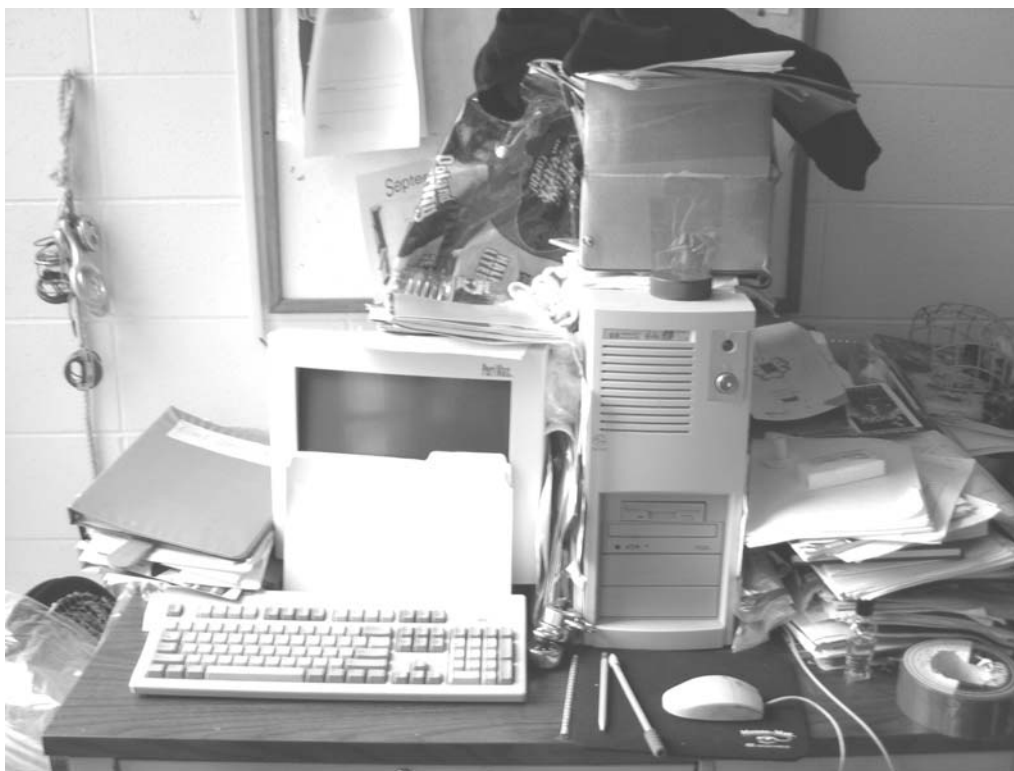
Picture 23

Accumulated Items in Office

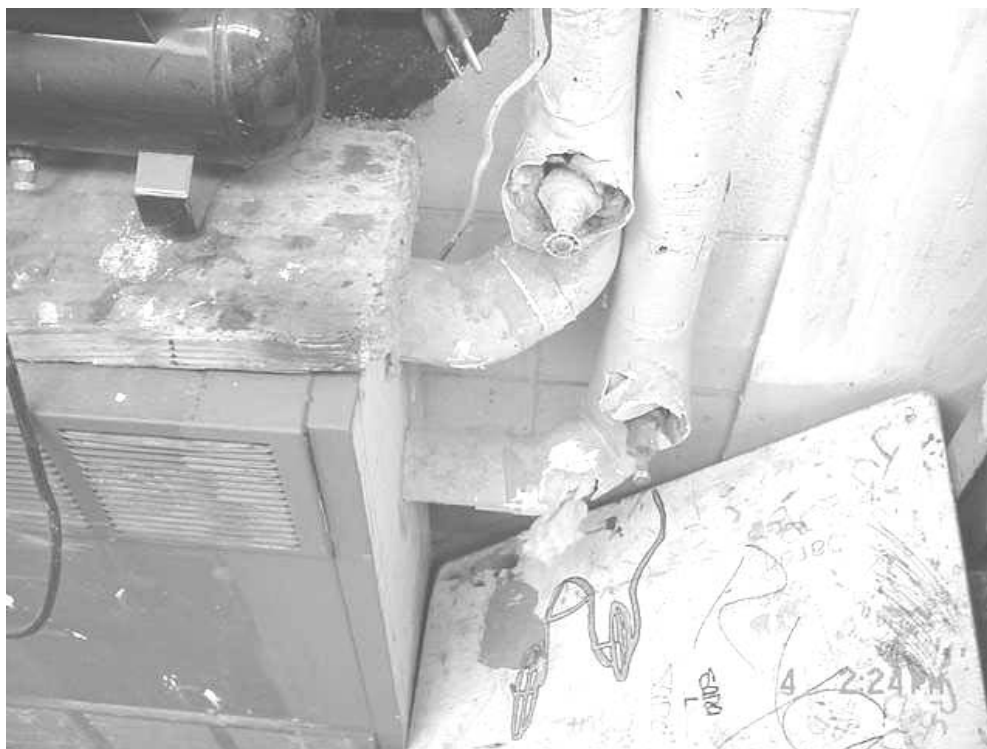
Picture 24

Lastly, exposed fiberglass insulation around pipes and open utility holes were observed in the art rooms (Pictures 24 through 26), the auxiliary gym (Pictures 27), room 223 (Picture 7) and as mentioned previously, the kiln room (Picture 17). Fiberglass insulation can be a source of skin, eye and respiratory irritation to sensitive individuals. Open utility holes can serve as a means for odors, dusts and particulates to migrate between rooms and floors. Musty odors were detected in the auxiliary gym which is located beneath ground level. Due to its subterranean orientation, the missing bricks can allow an earthy/musty odor to migrate into the auxiliary gym.

Exposed Fiberglass Insulation around Art Room Heating Pipes

14. Replace missing blocks or seal holes in auxiliary gym wall and seams around the edges of the floor to mitigate musty odors.
15. Re-wrap damaged fiberglass insulation around pipes in art rooms and other areas.

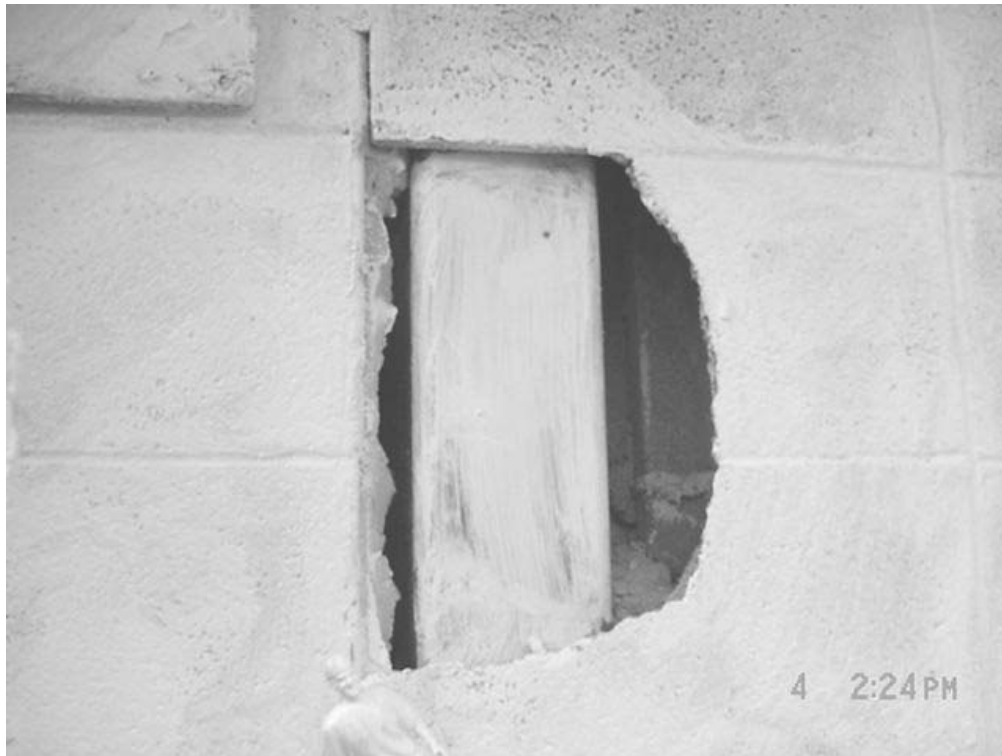
Picture 25

Hole in Art Room Wall
